# PRIMARY ADHESIVELY BONDED STRUCTURE TECHNOLOGY (PABST)

## PHASE Ib: PRELIMINARY DESIGN

DOUGLAS AIRCRAFT COMPANY  
MCDONNELL DOUGLAS CORPORATION  
LONG BEACH, CALIFORNIA 90846

TECHNICAL REPORT AFFDL-TR-76-141  
FINAL REPORT FEBRUARY 1975 - OCTOBER 1976

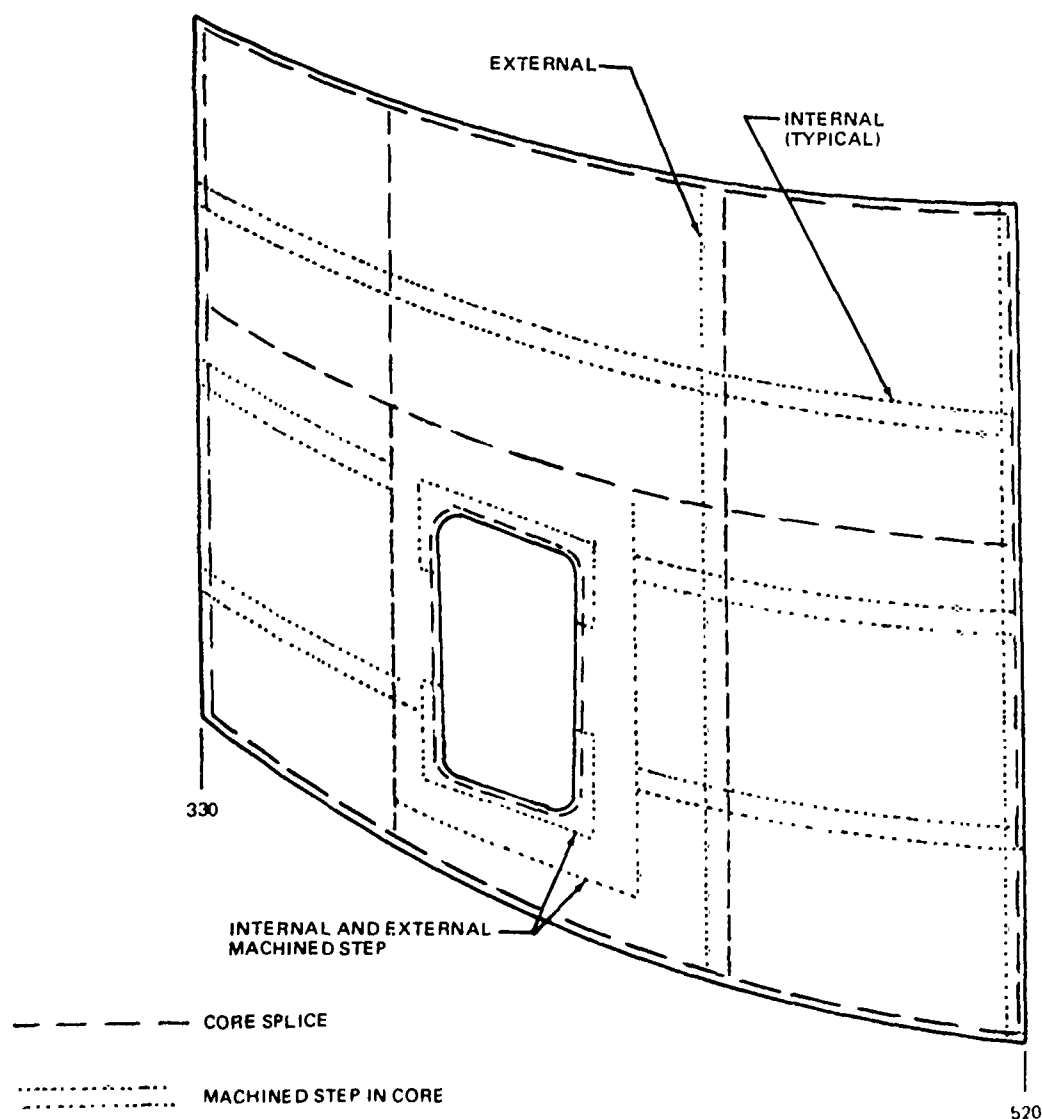
FIGURE 21. HONEYCOMB - TYPICAL CORE SPLICES AND MACHINED STEPS

The honeycomb core is basically 0.80 inch thick hexagonal cell. Core material is 5056 non-perforated, corrosion resistant aluminum, having a density of 3.4 pcf corresponding to a cell diameter of 0.250 inch and a cell wall thickness of 0.0015 inch. Typical core splices and core machine cuts are shown in Figure 21. At machined cut areas the core is machined on both sides so all doublers required for the face sheets can be buried between the outer and inner face sheets. This provides a smooth internal surface to facilitate the bonding of required intercostals and frames. Core splices were determined primarily because of handling requirements.

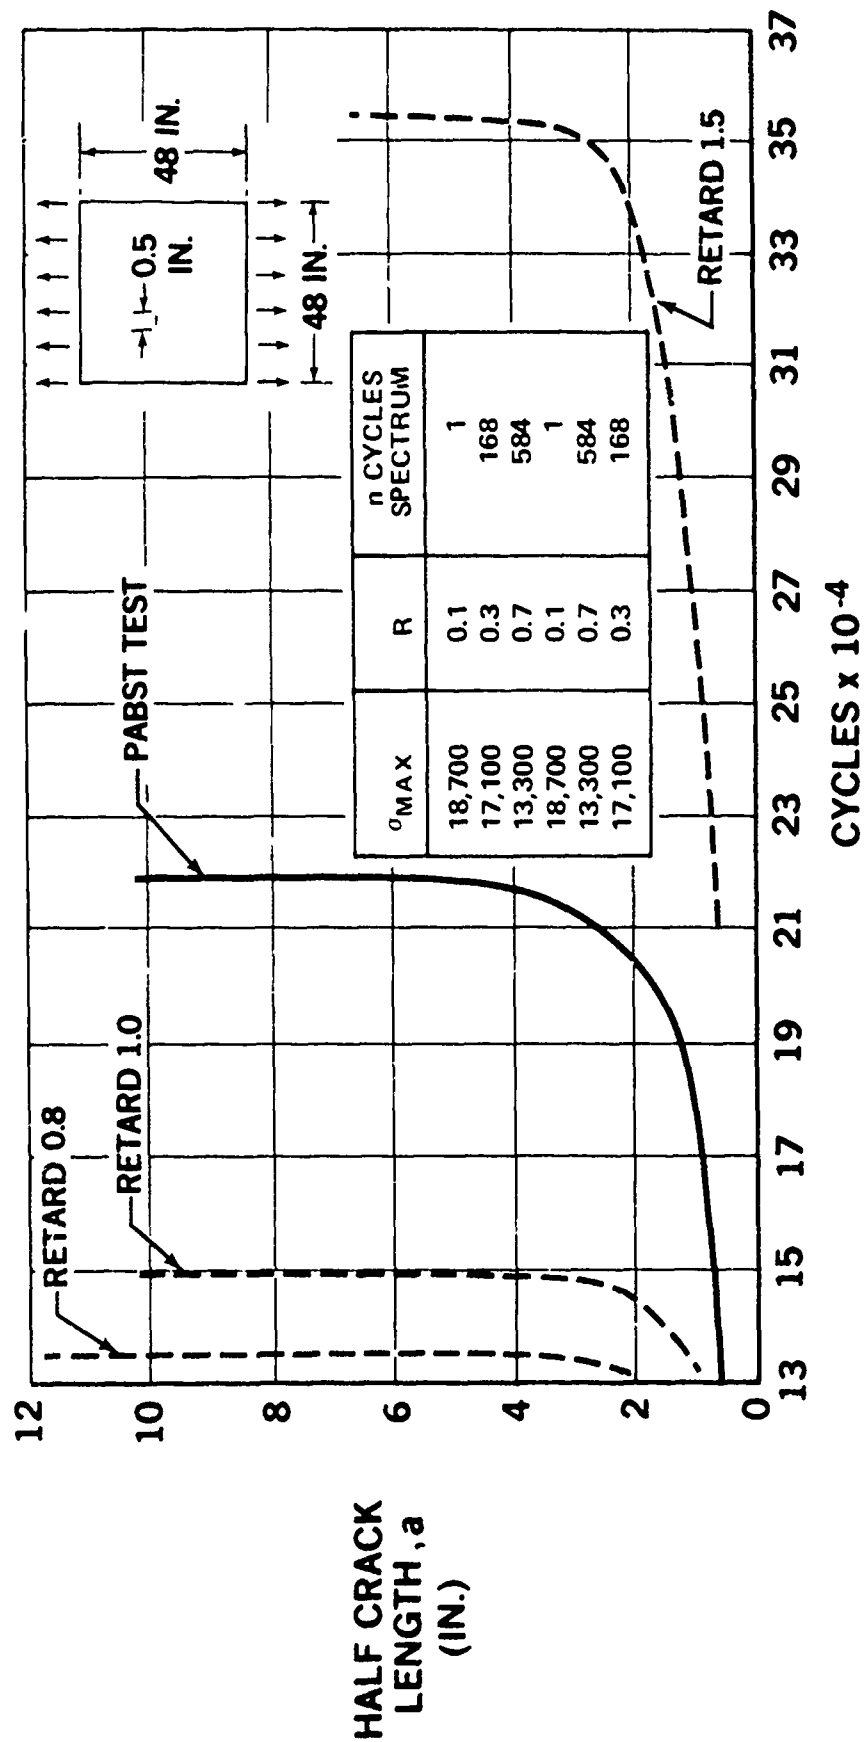
FIGURE 43. PABST RETARDATION ANALYSIS AND TEST DATA FOR 2024-T3 TL BARE

2024-T3 TL BARE  
WILLENBORG RETARDATION MODEL

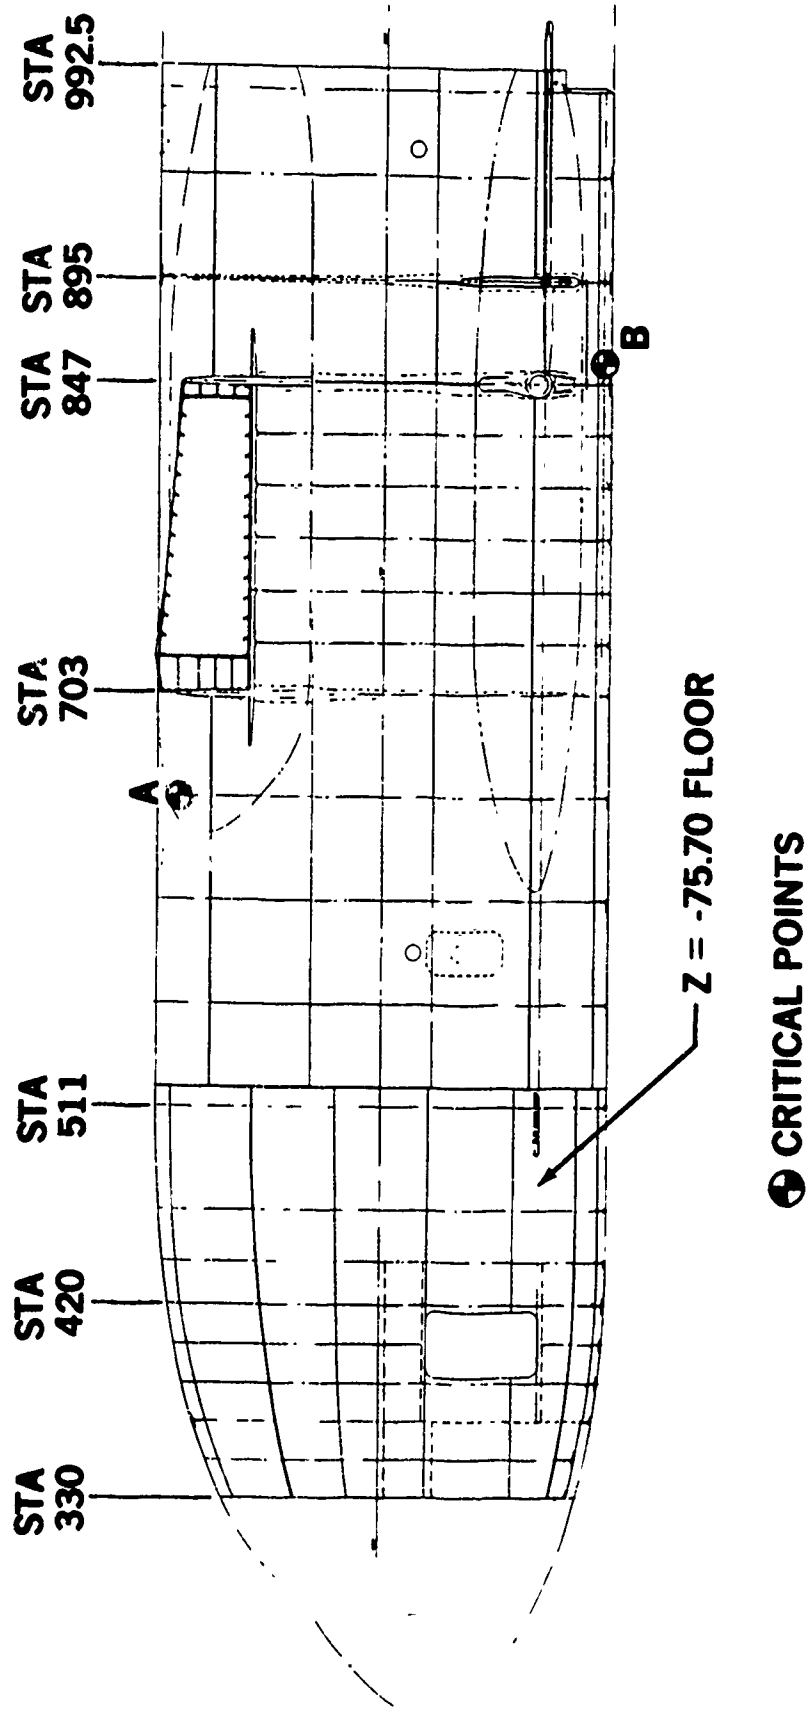
FIGURE 48. CRITICAL POINTS FOR THE HONEYCOMB CONCEPT

Honeycomb Concept: - The critical points for the analysis of the honeycomb concept are shown in Figure 48. As shown in the Design Concept section, almost the entire honeycomb fuselage has an 0.032 inch face sheet on the outside and an 0.020 inch face sheet on the side with the frames and fail safe straps. Critical point A was in the highest axial and pressure tensile stress area. Critical point B was under the floor in the region with highest axial compression as well as the pressure tensile stress. Since the geometry is constant throughout most of the honeycomb fuselage, these are the only

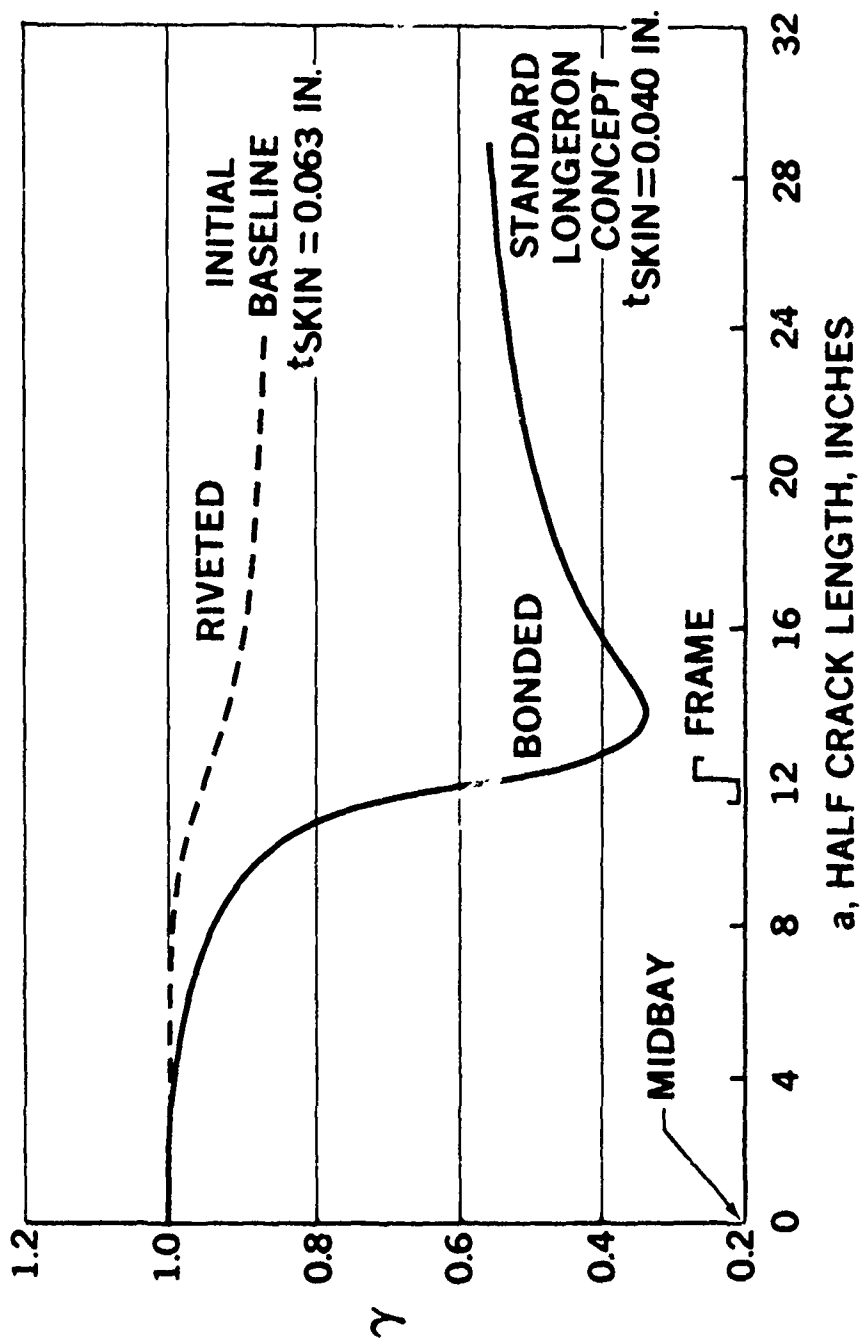
FIGURE 53. IMPROVEMENT PROVIDED BY BONDING

MODIFICATION FACTOR ( $\gamma$ ) ACCOUNTS FOR THE EFFECT OF STIFFENING  
ON A CRACKED SHEET

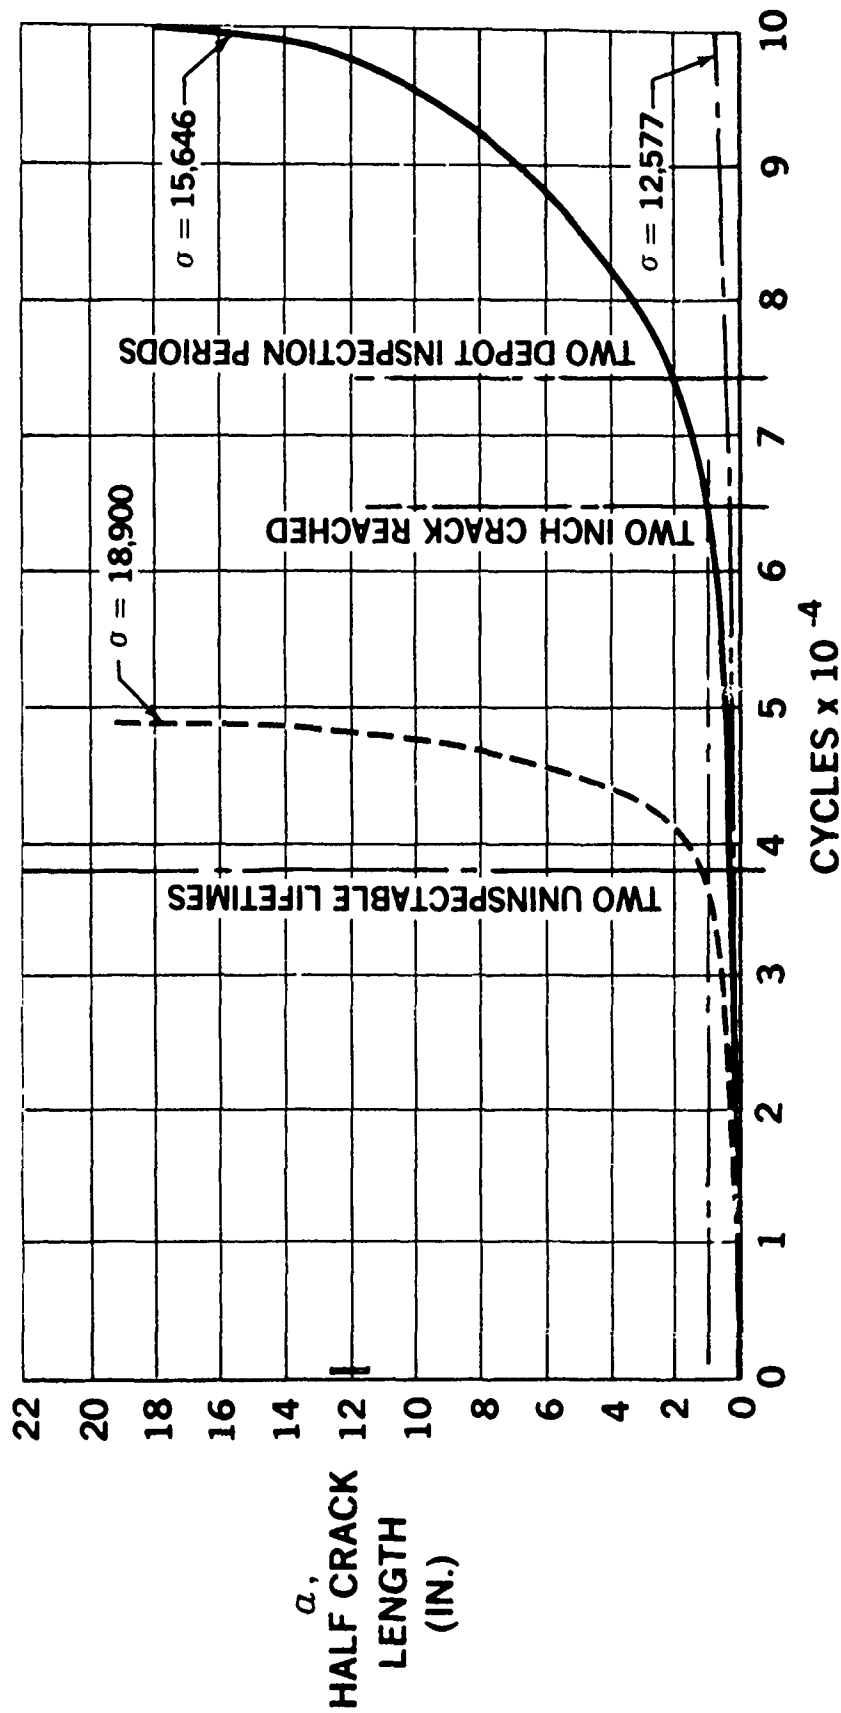
FIGURE 56. EFFECT OF VARYING STRESS LEVEL ON CRACK GROWTH FOR HONEYCOMB STRUCTURE

TEST SPECIMEN 30A — HONEYCOMB ONE BAY — "UNSTIFFENED HONEYCOMB"

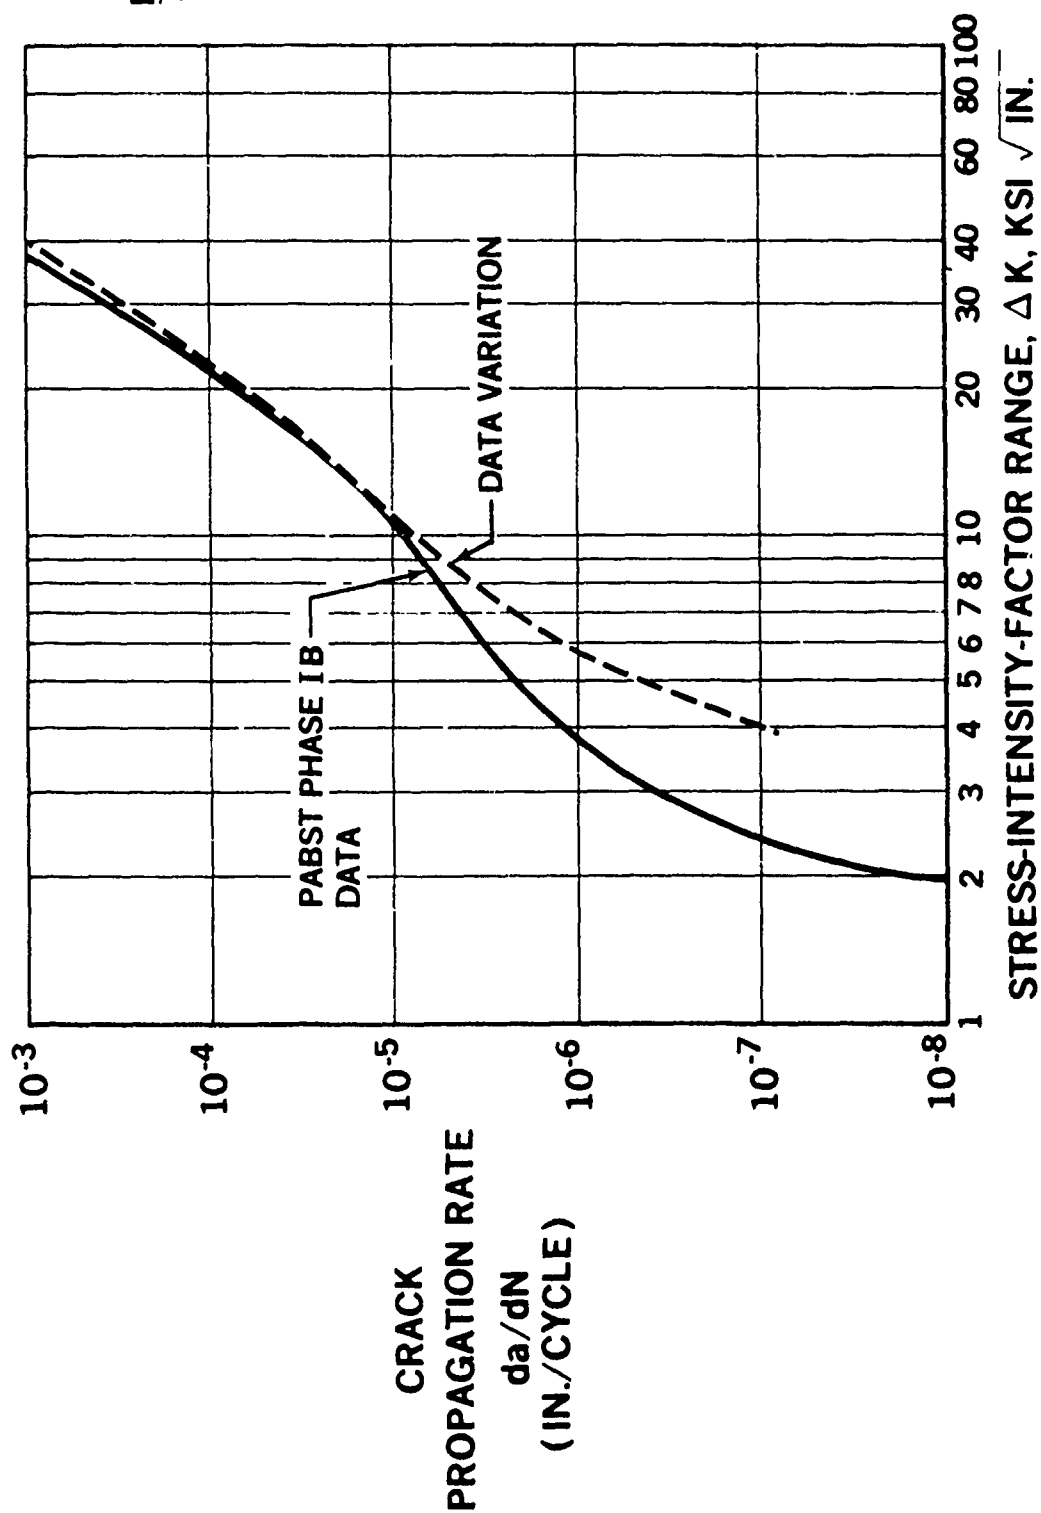
FIGURE 59. CRACK PROPAGATION DATA VARIATION FOR SENSITIVITY STUDY

EXAMPLE:  
7075-T6 SHEET

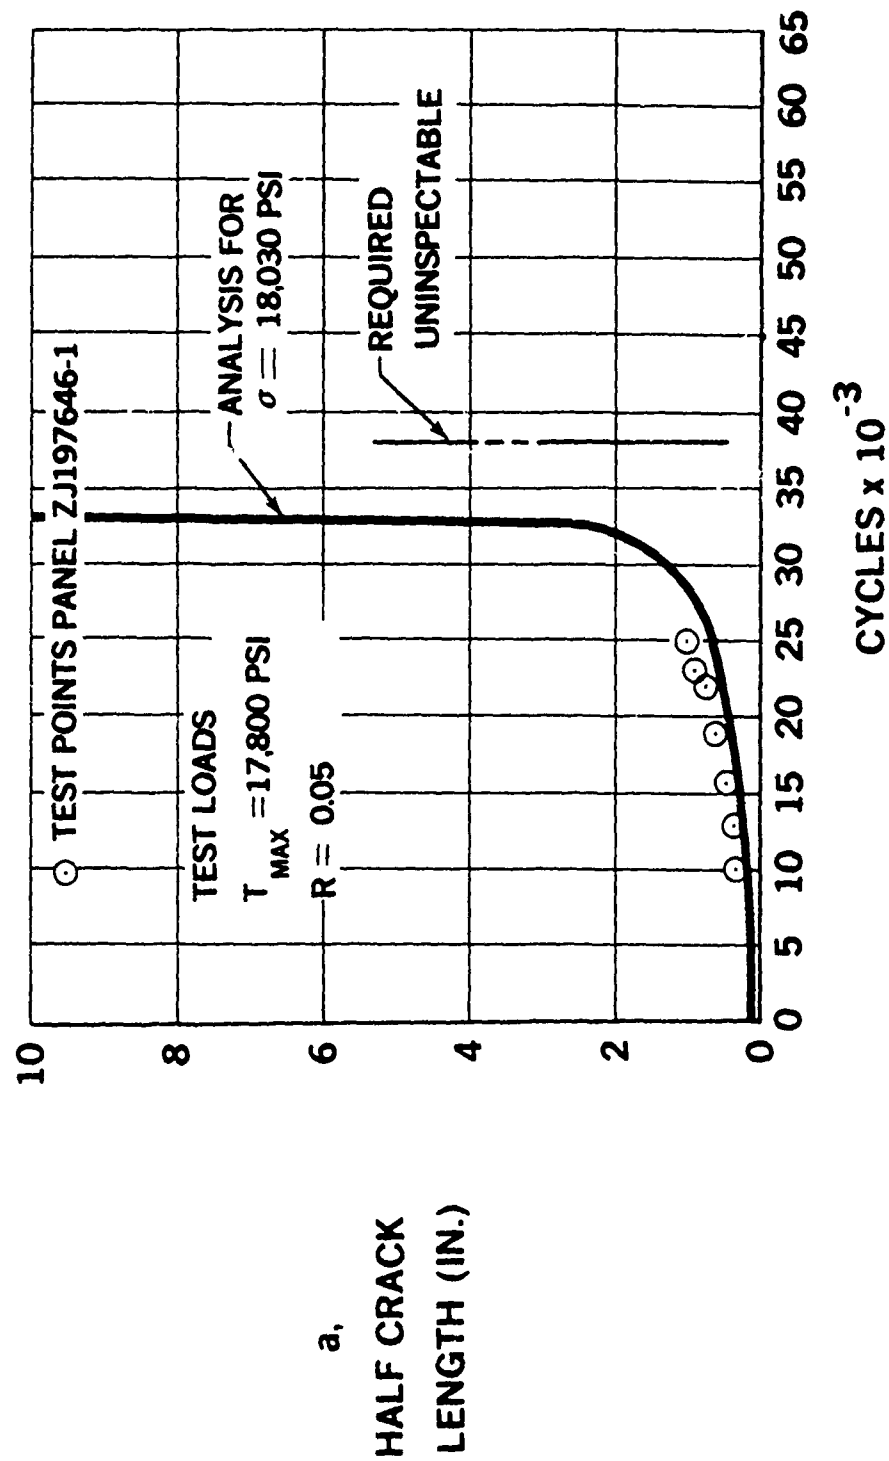
FIGURE 61. CRACK PROPAGATION ANALYSIS-TEST COMPARISON FOR AN INTERNAL LONGERON STIFFENED PANEL

# FLAT PANEL

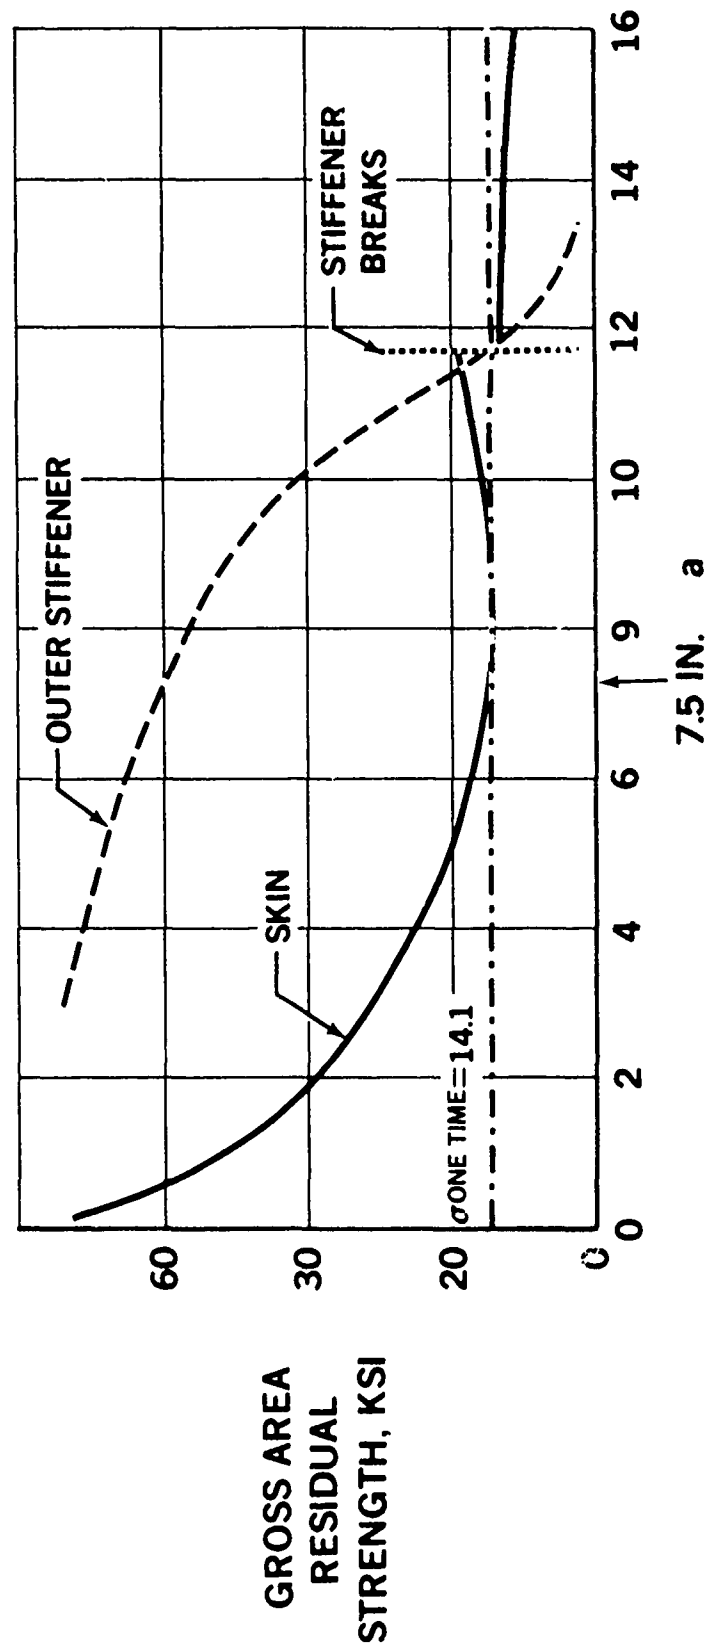
FIGURE 65. ANALYSIS-TEST COMPARISON FOR THE FOREIGN OBJECT DAMAGE OF AN INTERNAL LONGERON PANEL

- INTERNAL LONGERON — N21 — CURVED PANEL
- FOREIGN OBJECT DAMAGE — CRACK RS2
- TEST STRESS OF 14.1 KSI — NO FAILURE

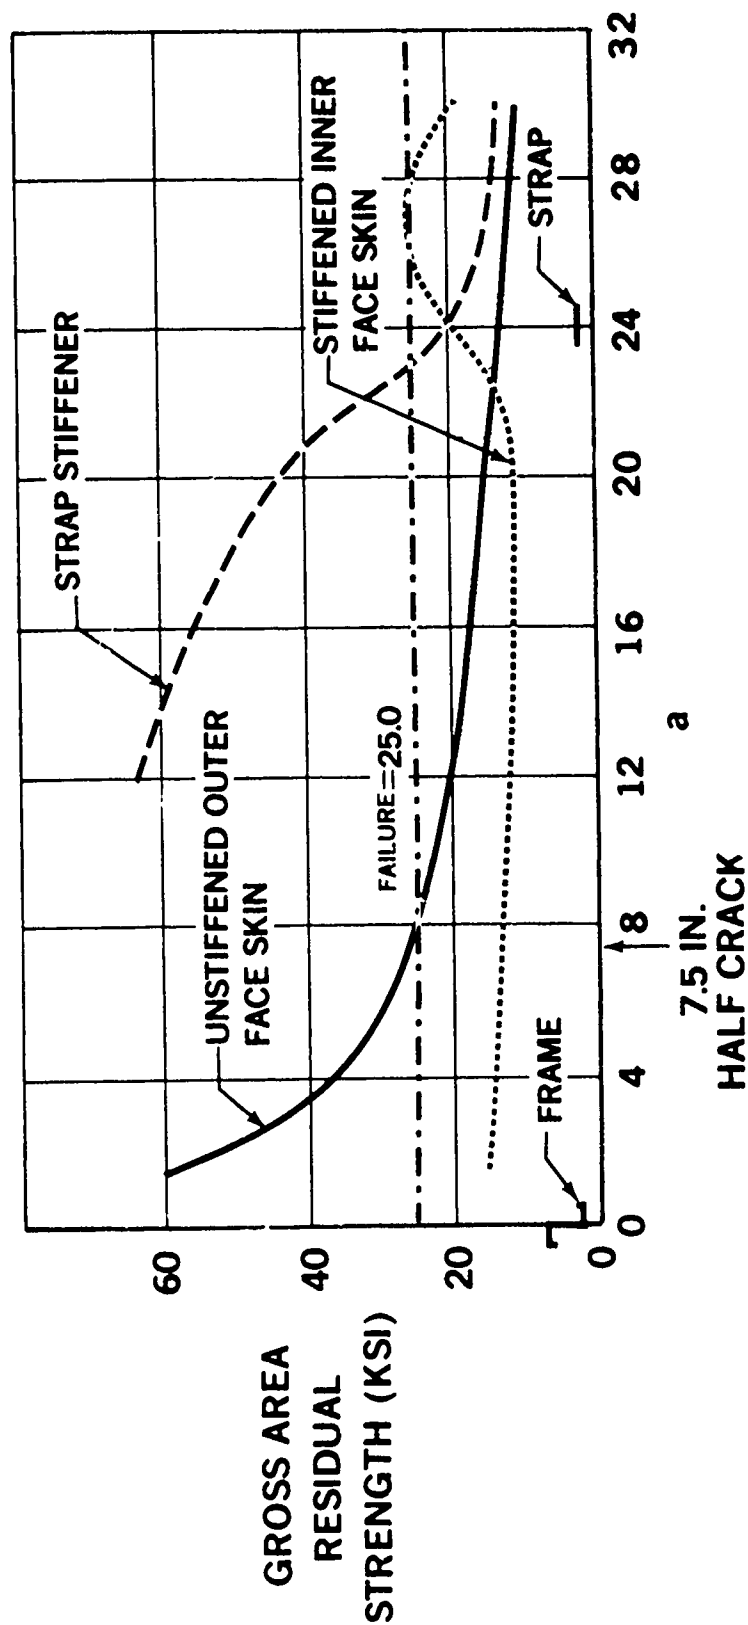
FIGURE 68. ANALYSIS-TEST COMPARISON FOR THE FOREIGN OBJECT DAMAGE OF A HONEYCOMB PANEL

- HONEYCOMB SPECIMEN 30C
- FOREIGN OBJECT DAMAGE — RESIDUAL STRENGTH
- FAILURE STRESS = 25 KSI

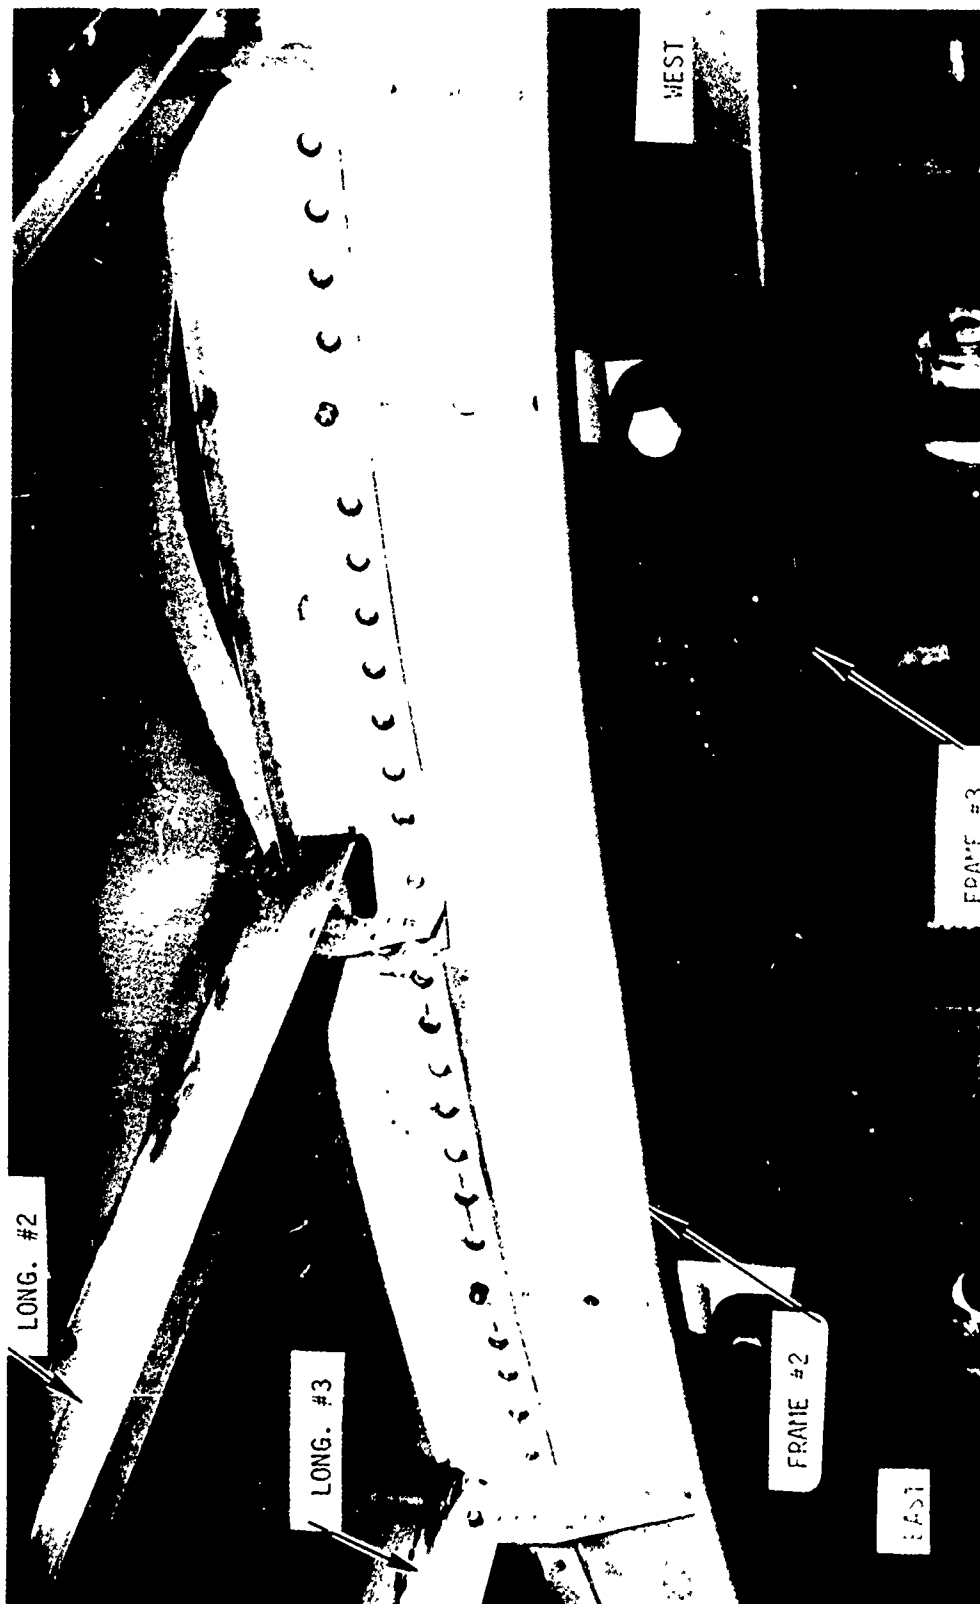
FIGURE 74. FRAME BENDING FAILURE

In the frame-bending test, Figure 74, it was definitely observed that the first failure was a break in the skin to a shear tee bond locally at the abrupt discontinuity in the shear tee where it was notched to permit the longeron to pass through. Once this happened, the skin over the shear tee cutout was free to buckle, thereby reducing the effective frame bending strength and stiffness at that location. The frame bent sharply and the bond between the skin and shear tee unzipped at two of the three frames in the panel. The load developed was sufficient to meet the design requirements but the mode of failure was so undesirable that the shear tee cutout area details will be improved for subsequent work. There was also some indication in the testing of some of the stiffened shear panels that the abrupt discontinuity in the shear tee triggered the failure. While all of the shear panels tested developed adequate strength, those with external longerons or honeycomb skin had uniform uninterrupted frames and attained consistently the highest strengths. It is now evident that the nature of the stiffening of shear panels can be more important even than the basic skin gage. If, as is often the case, the frame cripples locally at the frame/longeron intersection, local reinforcement of the frame outer cap or improved detailing of the intersection is a more expeditious approach to increasing the panel strength than raising the skin gage.

FAILURE LOAD 56,742 IN.-LB  
DESIGN LOAD 50,000 IN.-LB

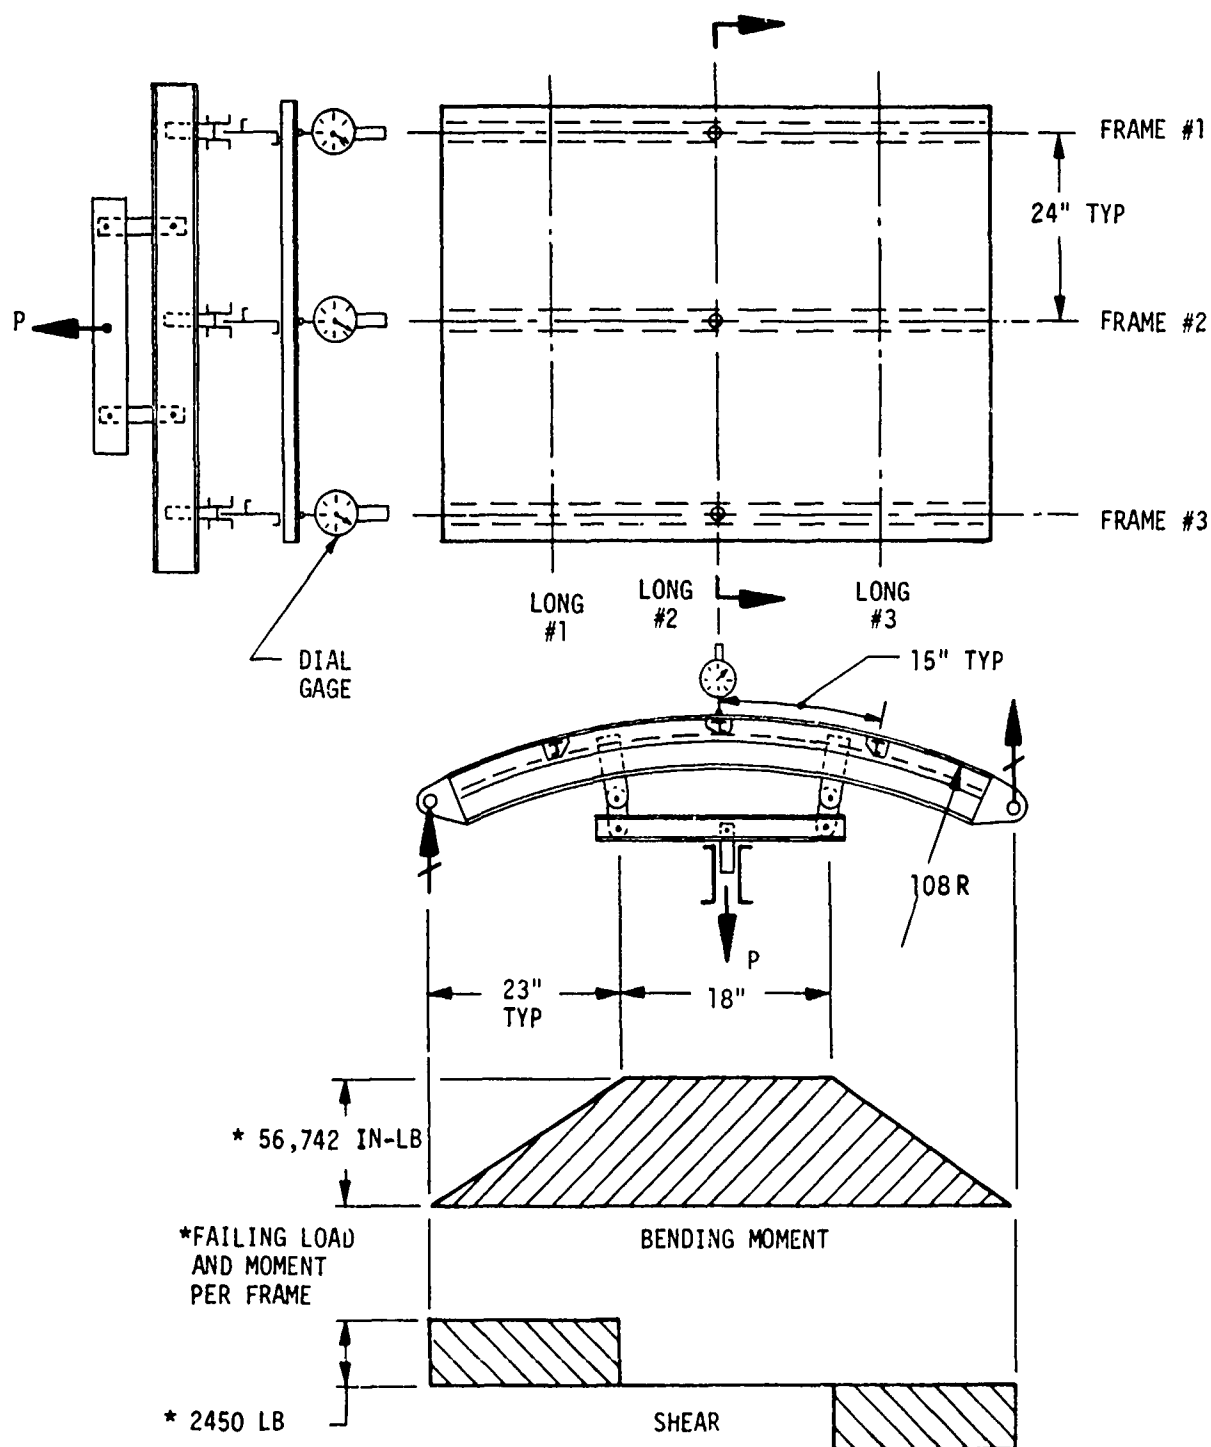
FIGURE 80. FRAME BENDING TEST (SPECIMEN 23)

Frame Bending Test. - These tests determine the static strength of a typical frame-longeron-skin combination, Specimen 23 on Figure 79, under pure bending in the frame. The test setup and frame section properties are shown in Figures 80 and 81 respectively. The test results are shown in Figure 73. Initial failure occurred for a one-inch length in the bond between the skin and frame tie shear clip, starting at the edge of the shear clip cutout for the longeron, followed by complete disbond between longerons and subsequent frame crippling.

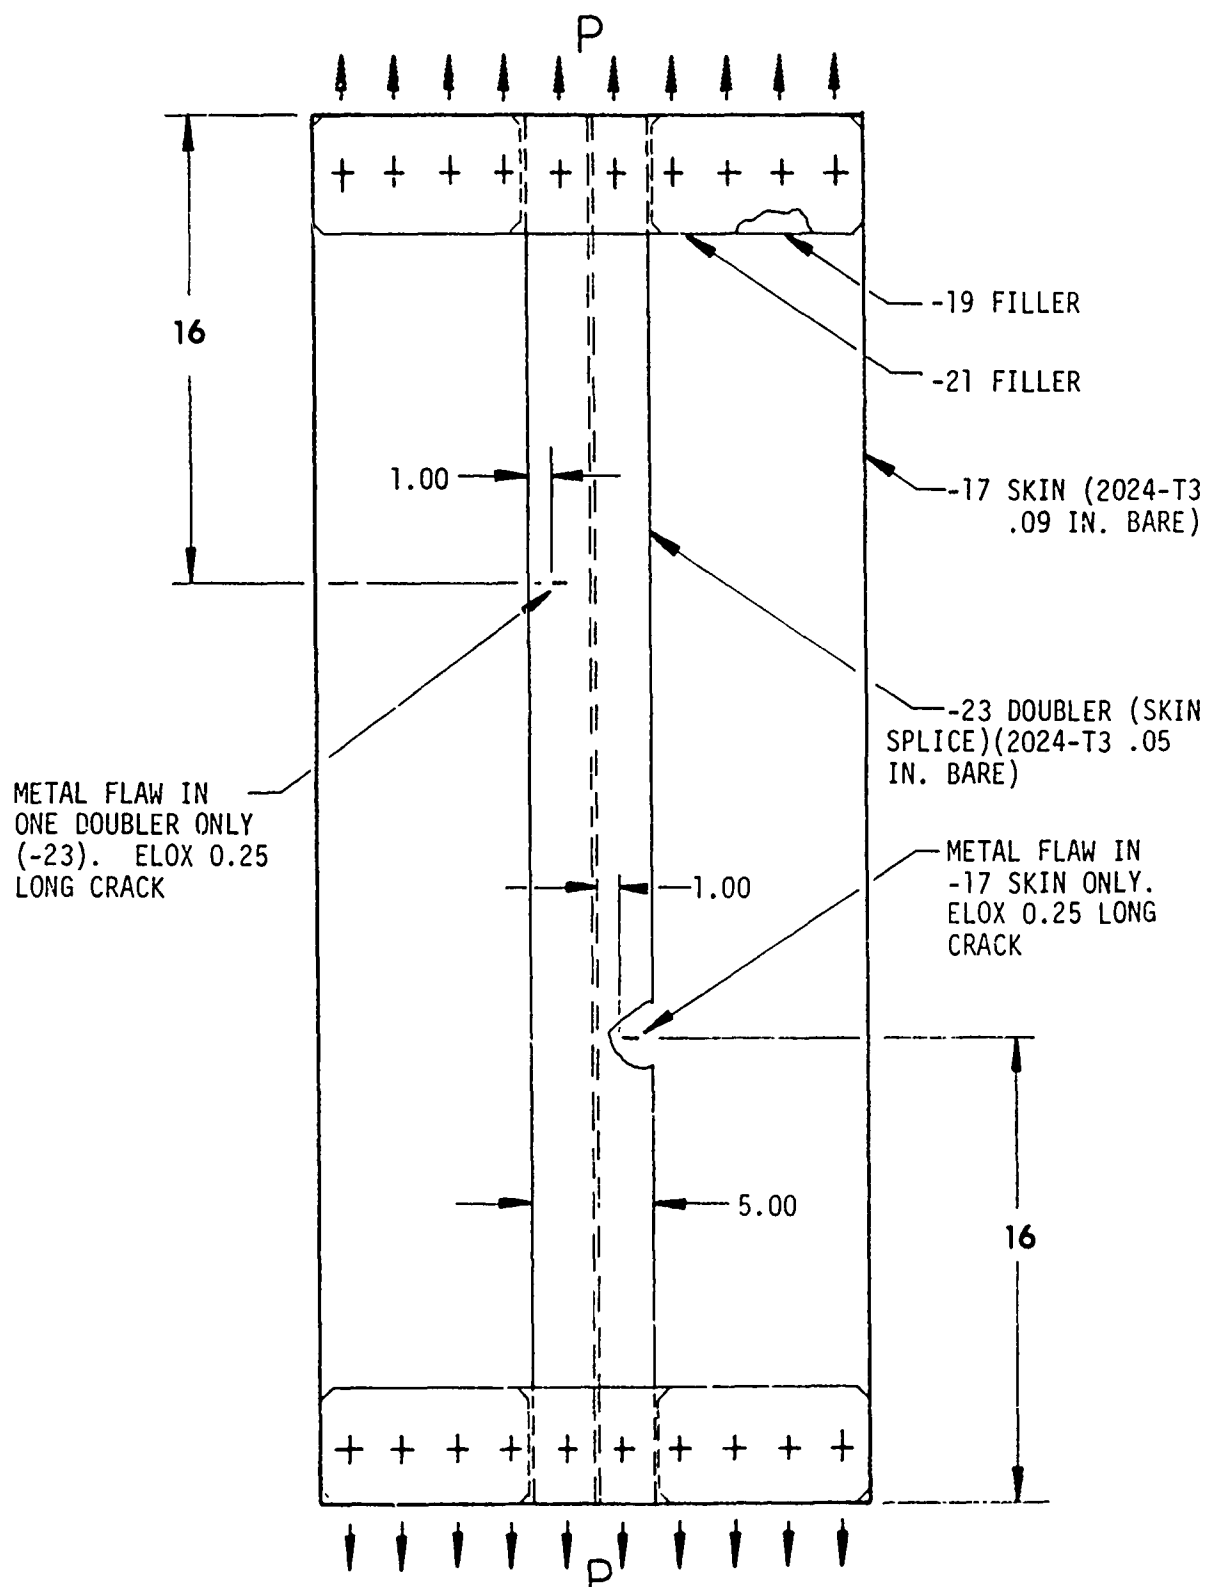
FIGURE 88. BONDED SKIN SPLICE SPECIMEN 4A WITH METAL FLAWS

Two strain gages were installed on the panel. One on the doubler over the elox slot in the skin and the second on the doubler opposite and over the elox slot in the doubler. The crack growth in the skin was monitored by X-rays until the crack grew past the splice doubler. Table 24 gives the crack length and associated strain gage data as functions of cumulative fatigue cycles.

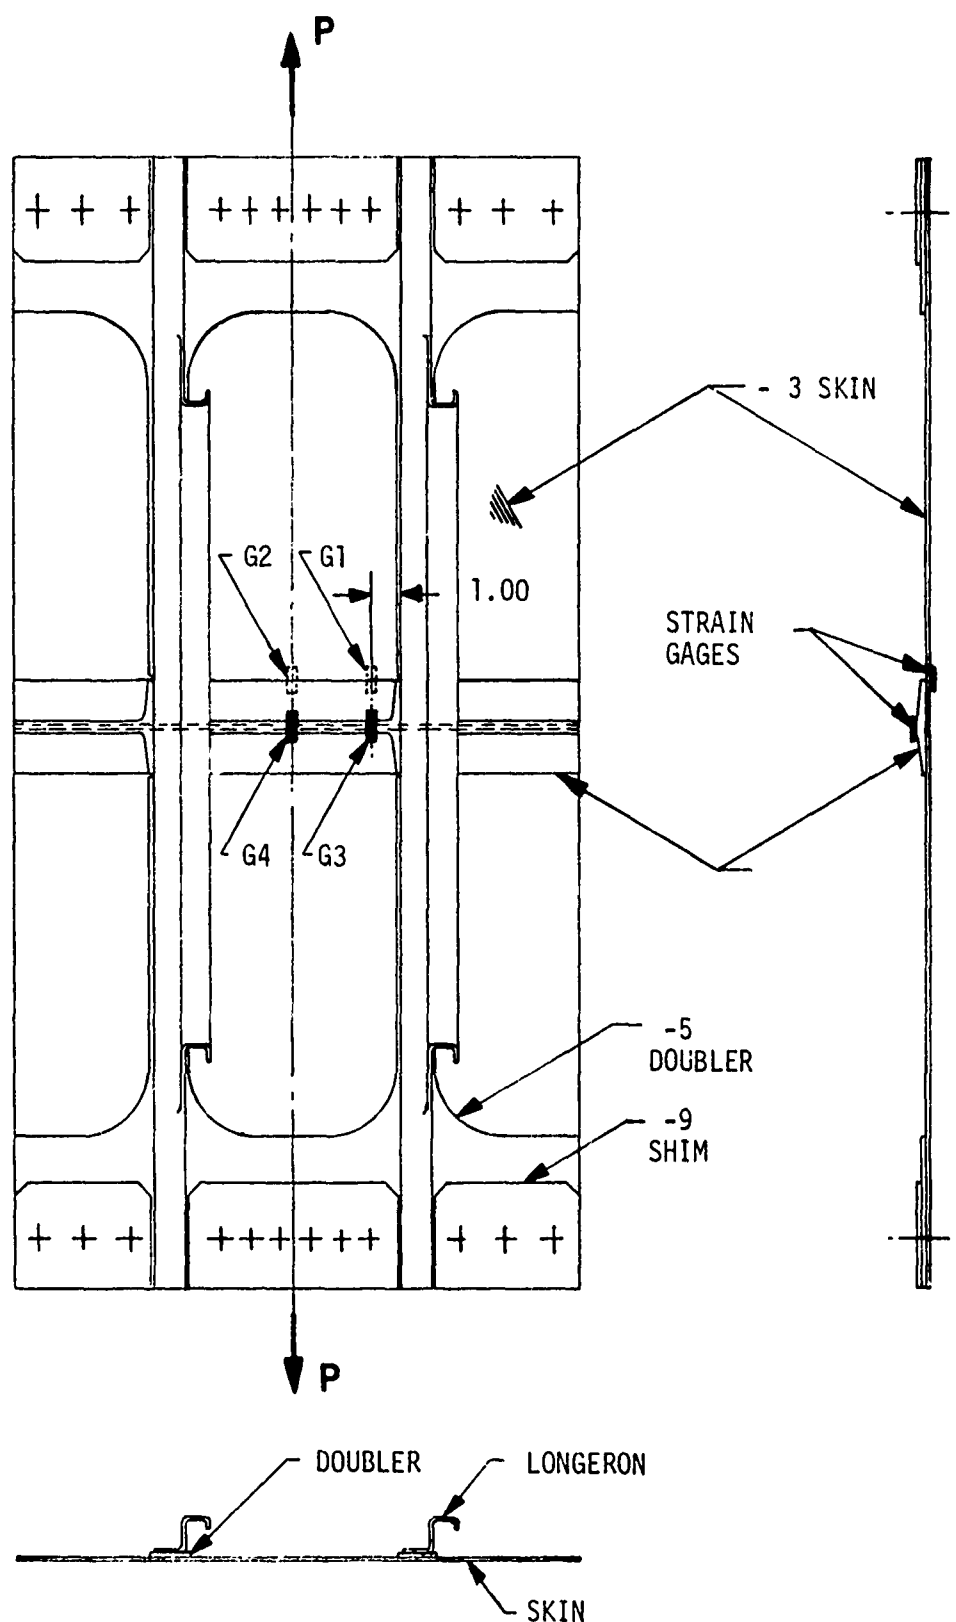
FIGURE 93. ADHESIVE BONDED, SINGLE LAP, HOOP SPLICE SPECIMEN

\* Panel failure occurred at 33,400 cycles at maximum load.

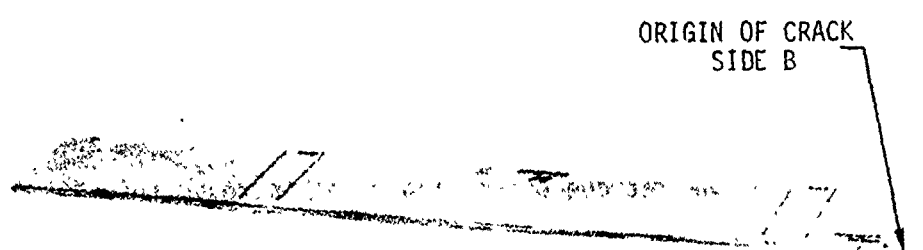
FIGURE 94. CRACK ORIGIN IN SKIN SPLICE

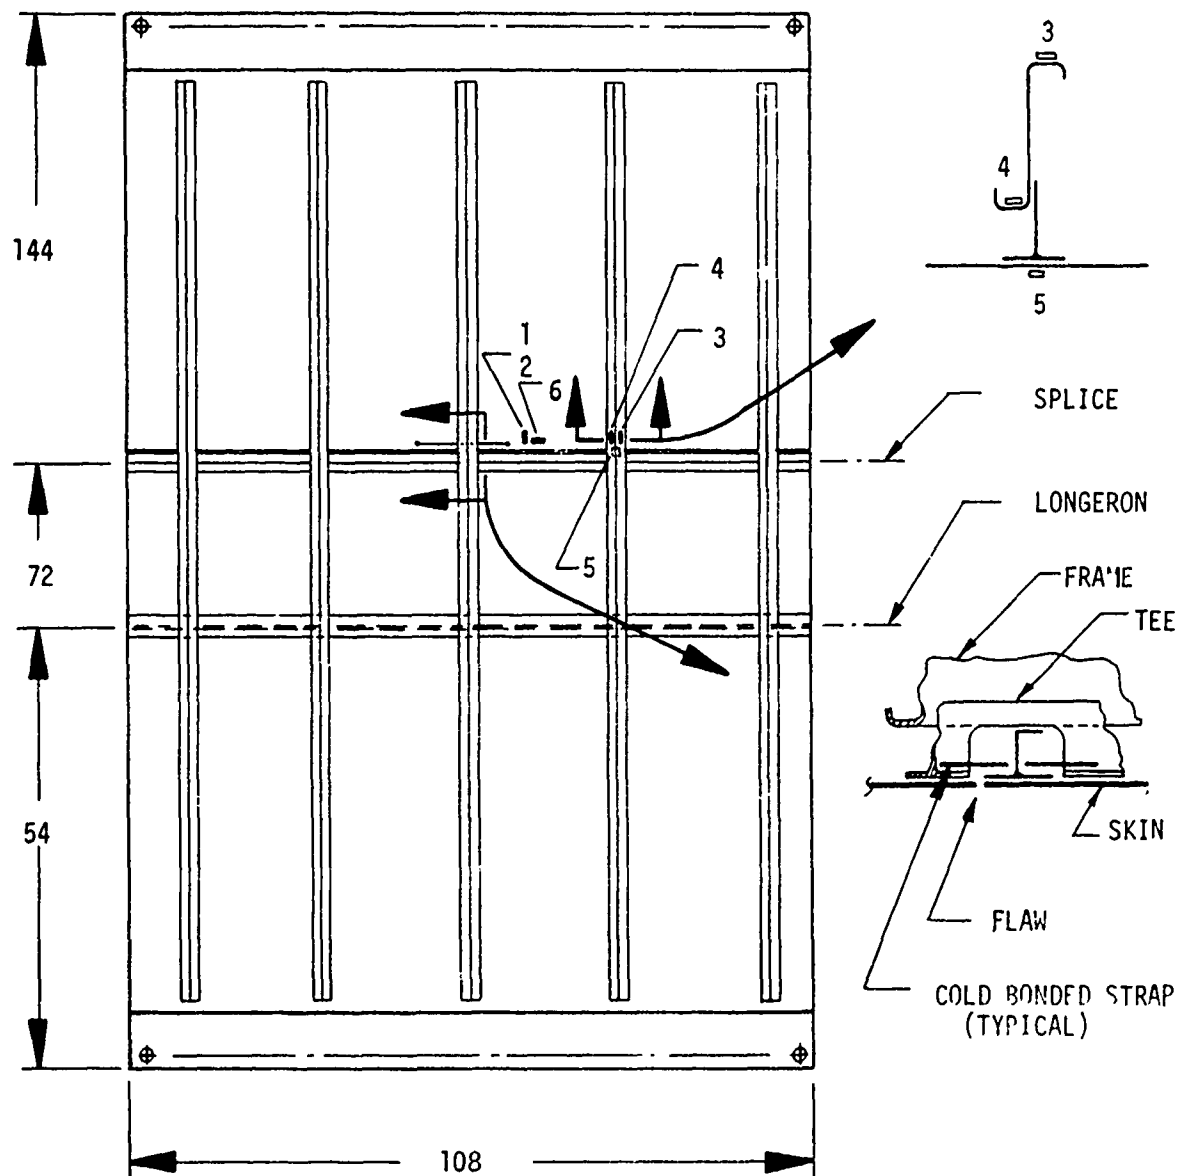
FIGURE 99. TEST SPECIMEN N30AB

Note: Strain gages 1 through 6 are located as shown. Strain gages 1 and 2 are back to back.

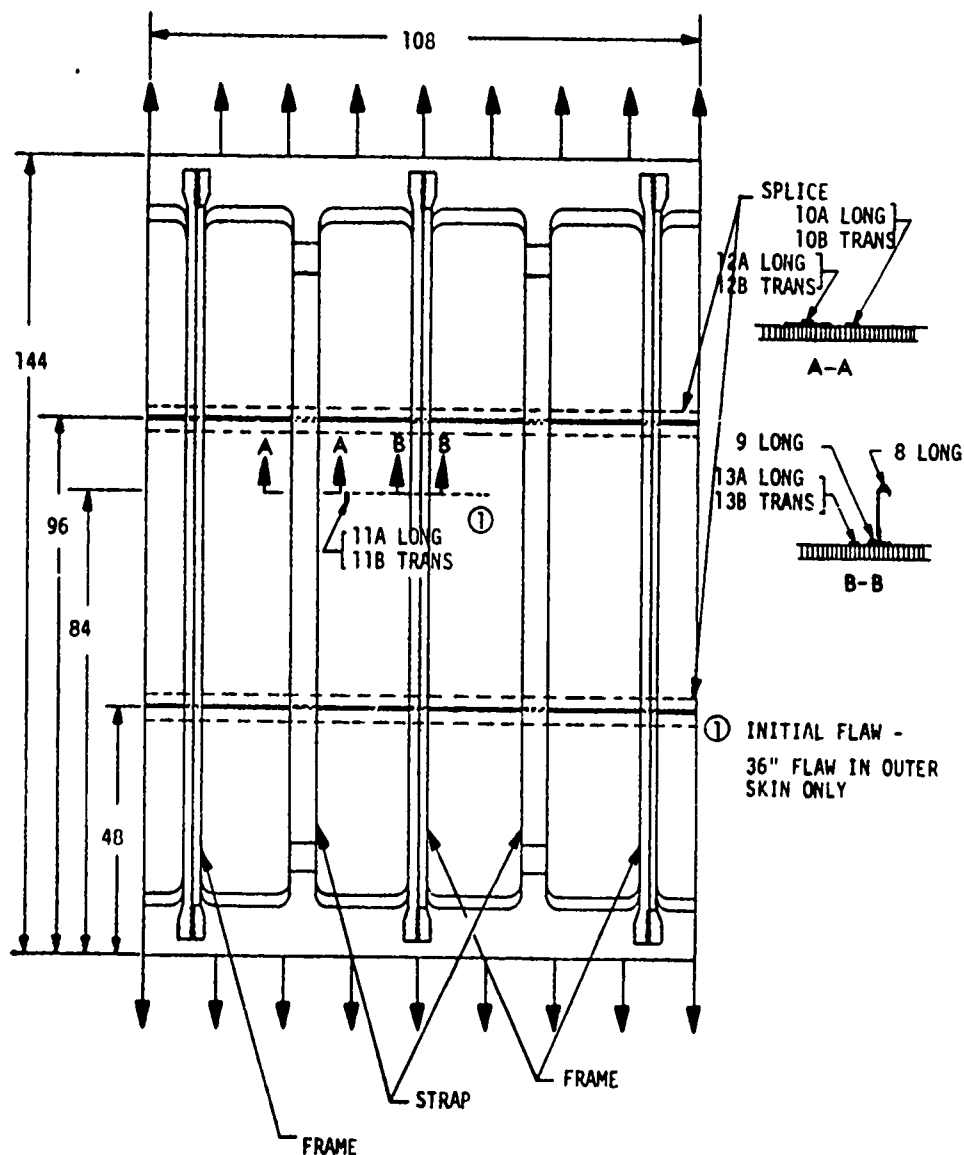
FIGURE 107. PANEL GEOMETRY, STRAIN GAGE AND INITIAL FLAW LOCATIONS-H30B

Figure 107 shows the panel geometry with strain gage and initial flaw locations. The panel was made of 2024-T3 bare sheet aluminum honeycomb sandwich panels. The panel splice doublers were also of bare 2024-T3 sheet. The longitudinal straps were of 7475-T761 bare aluminum sheet and the frames of 7075-T6 aluminum. The panel was loaded to 100,000 pounds in 20,000 pound increments. From 100,000 pounds to failure, the load was increased in 10,000 pound increments.
